# THE EFFECT OF THE SEPTEMBER 1985 EARTHQUAKES ON THE CONSTRUCTED FACILITIES OF MEXICO CITY

## PART I. STRUCTURAL ASPECTS

SECOND REPORT OF THE ENGINEERING INSTITUTE OF THE  
NATIONAL UNIVERSITY OF MEXICO (UNAM)

November 1985

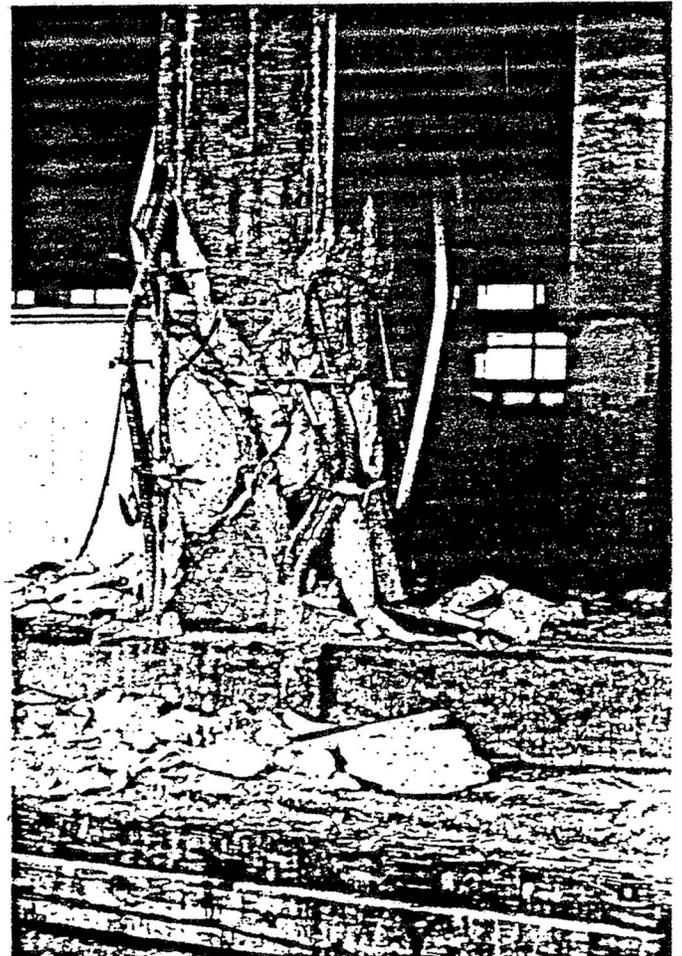
Falla de columna por cortante  
y carga axial

Failure of column by  
shortening and axial load

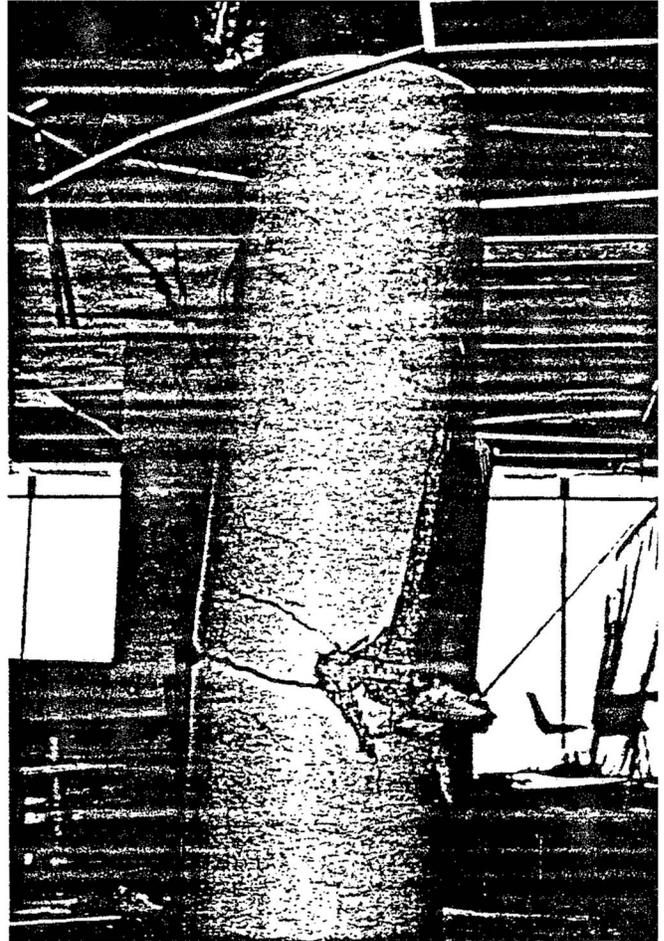
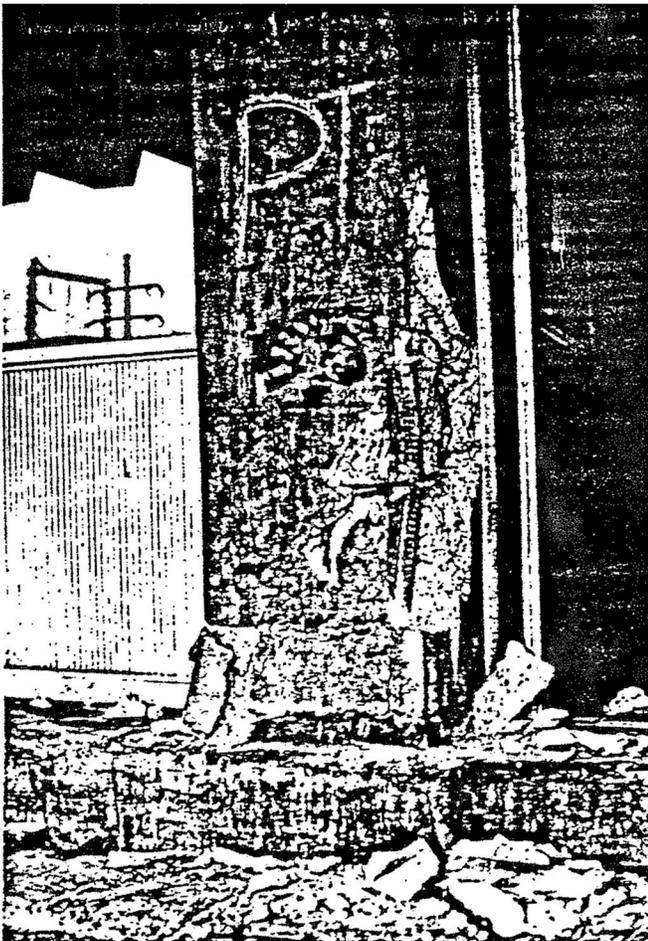
Falla de columna zunchada

Failure of a spirally  
reinforced column

Falla de columna con desgarramiento del concreto por excesiva concentración de refuerzo longitudinal en paquetes en las esquinas

Failure of column with tearing of concrete due to excessive concentration of longitudinal reinforcements packed in the corners

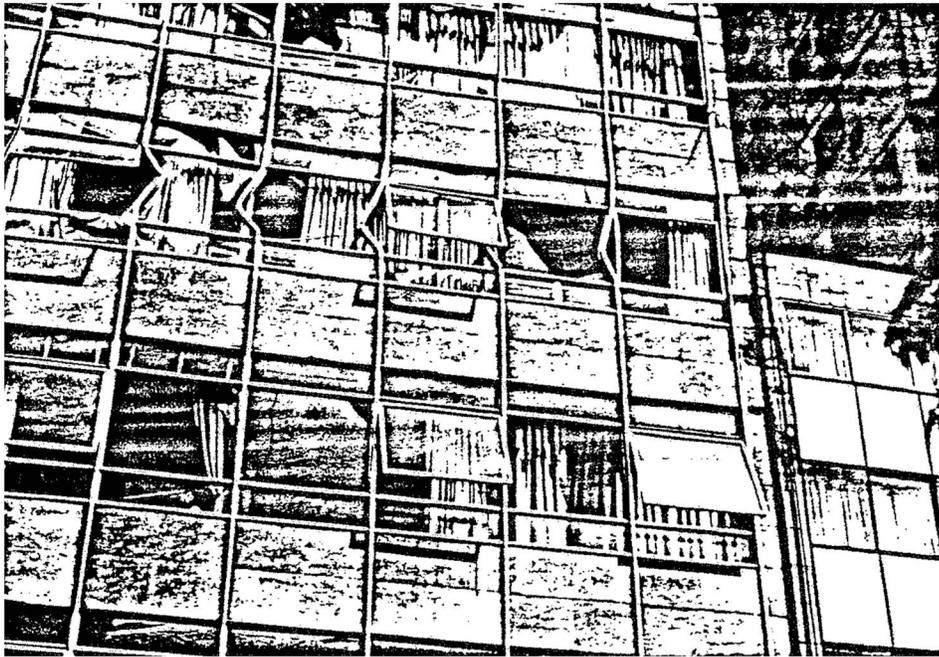
Falla de un entrepiso probablemente propiciada por choque con el adyacente

Failure of a between floor probably caused by collision with an adjacent

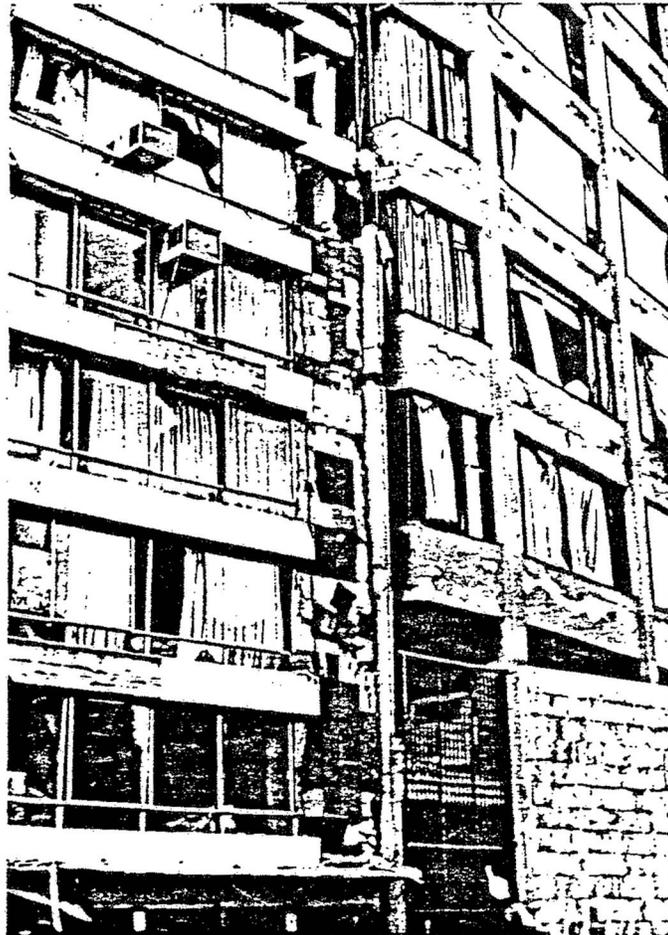
- e) Collisions with adjacent buildings. In more than 40 cases of damaged buildings, evidence of collisions with adjacent buildings was observed. On occasion this caused only local damage in the structure in the outer layers. There are cases where the impact provoked a weakness in a floor which was the principal cause of its collapse. One supposes that this fact is responsible for a good number of the failures observed in the upper floors. It is apparent that the requisite regulation of a minimum separation between adjacent buildings was violated in a systematic manner. The separation between contiguous buildings was on the order of 10 cm, which is clearly insufficient.

Daños por choques entre edificios adyacentes  
Damages caused by collision with adjacent buildings

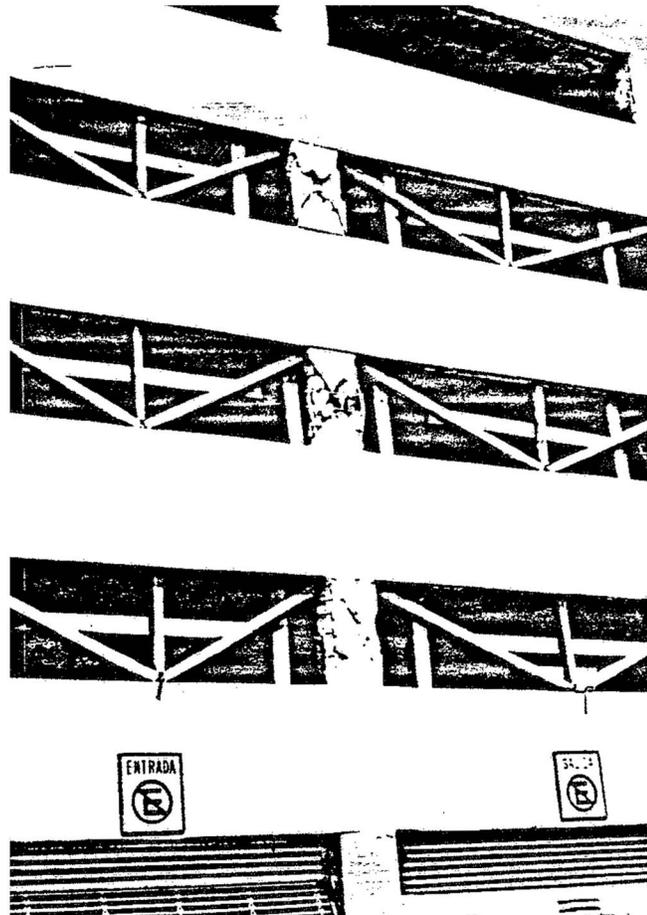
- d) Short columns. In this category are identified cases where columns on some axes were restricted in lateral deformation by masonry walls or by stone or brick facades. This situation makes them more rigid than columns on other axes, and hence they absorb a major fraction of the lateral forces for which they were not generally designed, giving place to weakness failure generally through shear. This characteristic was found in 15 of the most damaged buildings.

Falla de columnas cortas  
Failures of short columns

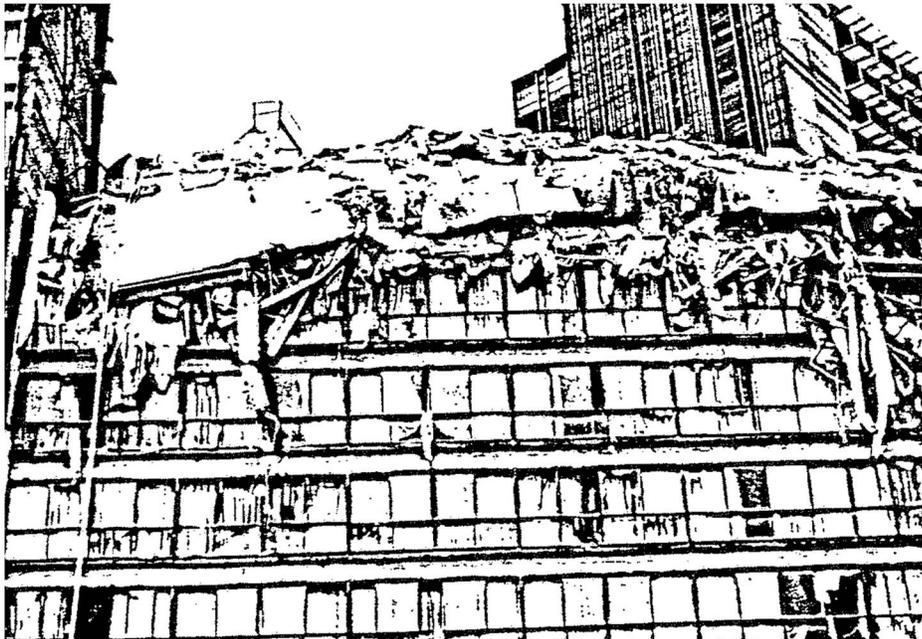
- f) Failures in the upper stories. The number of failures in the upper stories was notable. Of the total number of partial and total collapses, close to 40% corresponded to collapse of a floor in the upper third of the structure. The number of cases of grave damage to the upper third

parts of structures were very high. Only a fraction of these cases could be explained by weakness caused by the collision of buildings. In others these failures could be attributed to abrupt reductions in resistance and rigidity in the affected levels of the structures due to a diminution in a section of columns and walls or to a weakening by a reduction of the transverse reinforcement.

Falla de pisos superiores  
Failure of upper floors

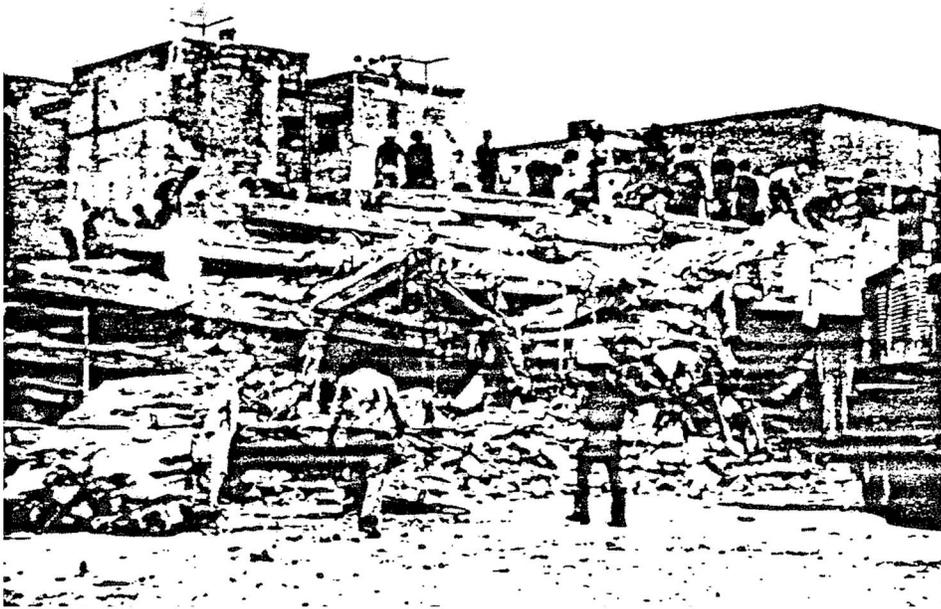
Colapso de edificio por inestabilidad lateral  
Collapse of building through lateral instability

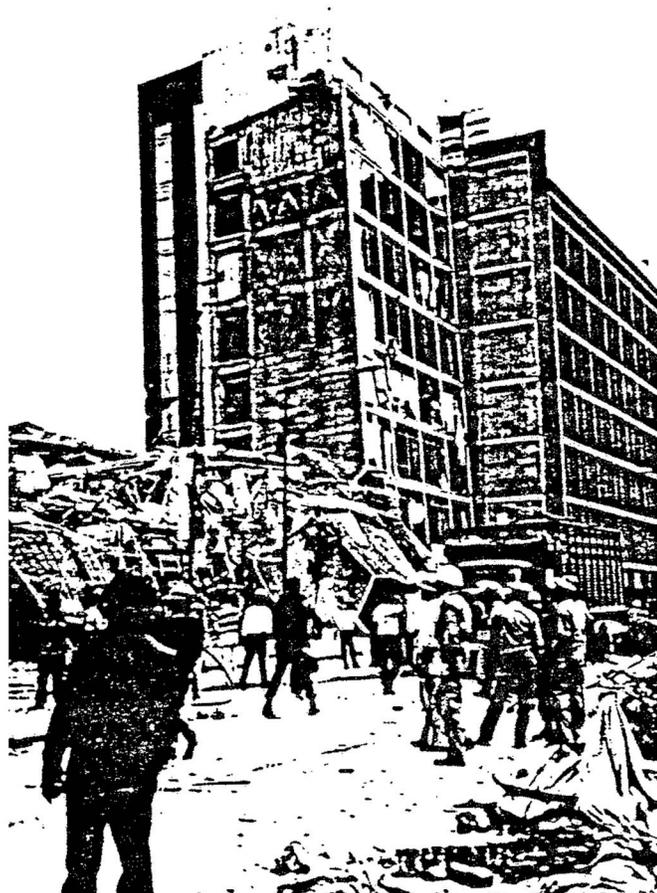
Inclinación de edificio por hundimiento  
Leaning of building through settlement

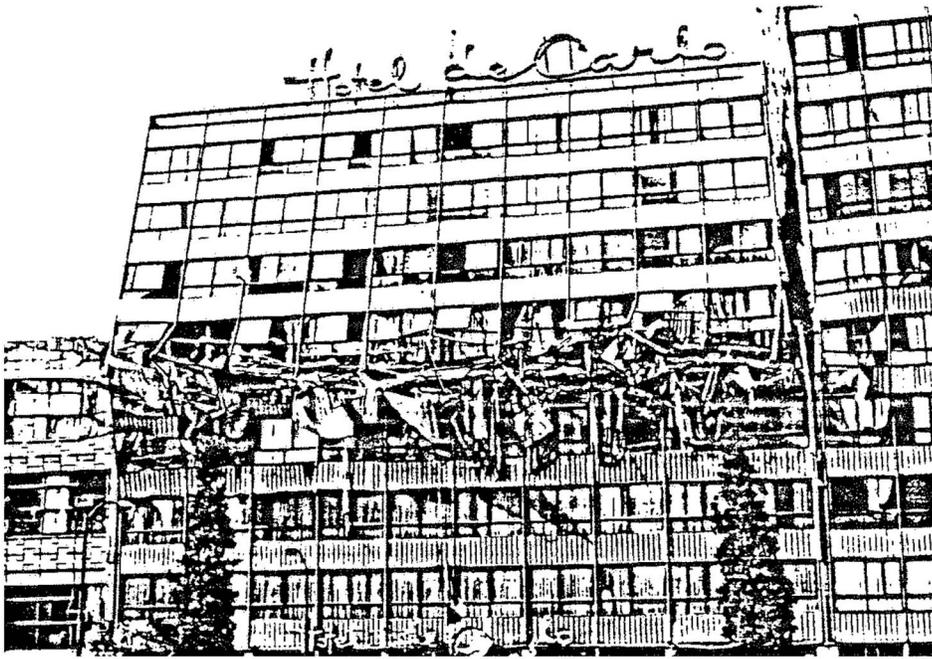
Falla de pisos intermedios  
Failure of intermediate floors

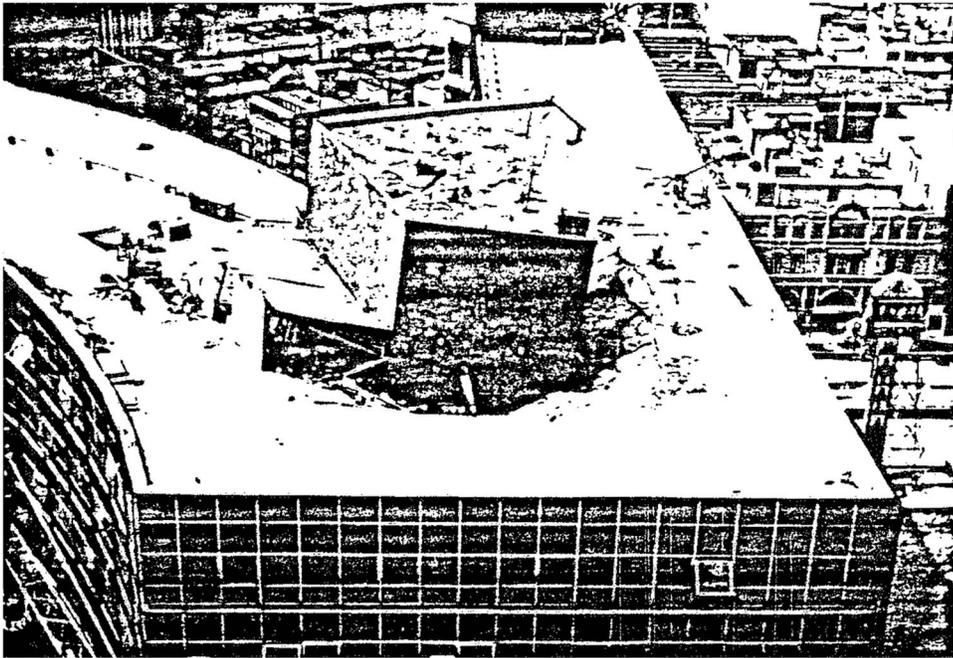
Falla de apéndices de edificios  
Failure in additions to buildings

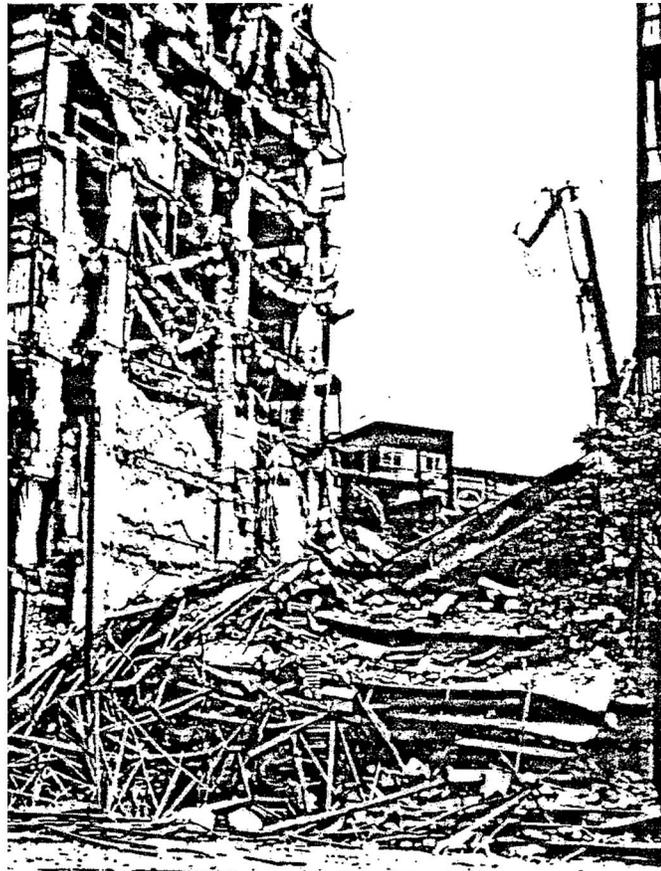
- i) Bad behavior of waffle slabs. A high incidence of collapse and grave damage has been indicated in buildings made with concrete columns and waffle slabs, of close to double that which occurred in buildings with a concrete frame. These structures were highly flexible and had a reduced ductility. In the majority of the cases the failure was across the columns, but in close to half a dozen of the cases there occurred a failure through a puncturing of the slab by the shear forces due to the sum of the effects of the vertical loads and the earthquake. In different buildings of this type, diagonal cracks occurred in the slabs around the columns, symptomatic of incipient failure by puncturing. In the majority of cases of this type of failure it was evidently lack of a solid zone of concrete for appropriately reinforcing around the column.

Colapso por punzonamiento de losas reticulares  
Collapse through punching of waffle slabs

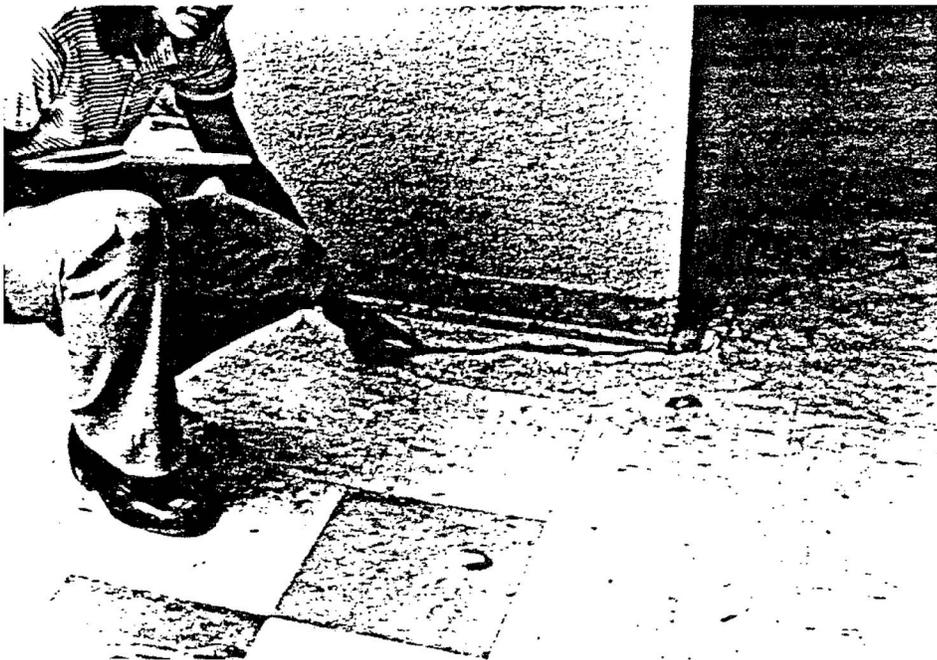
Falla incipiente por cortante en losa reticular  
Incipient failures through shear in waffle slab

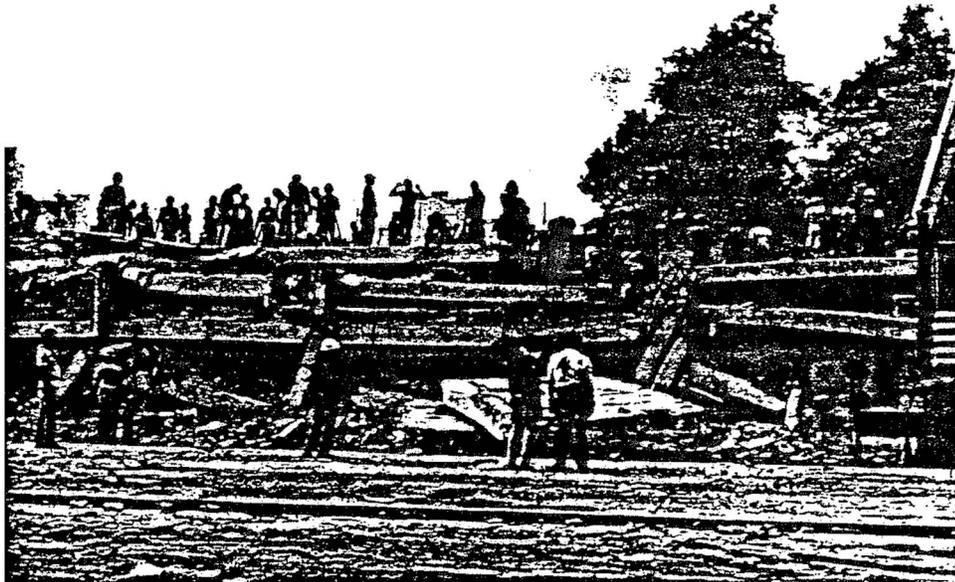
Colapso de edificio por pérdida de capacidad de carga vertical  
Failure of a building through loss of capability of vertical load

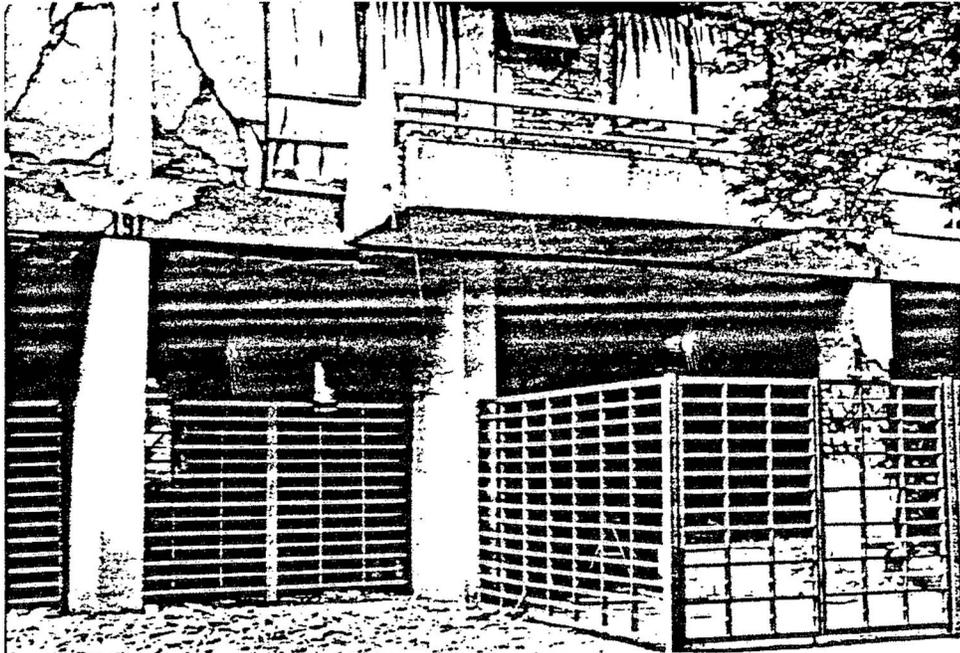
Falla en columnas de edificios con planta baja débil  
Failure in columns of buildings with a weak ground floor

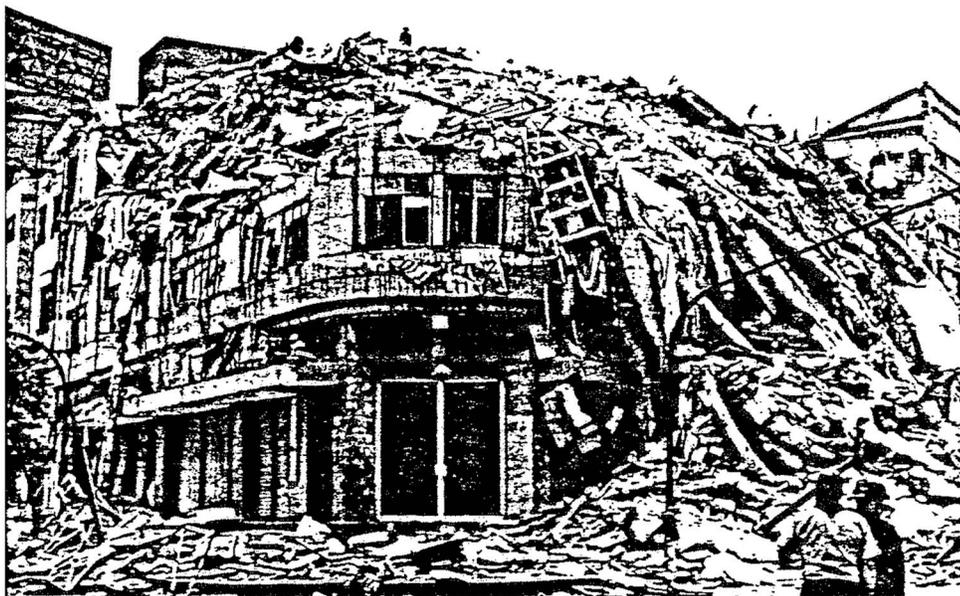
- b1) Asymmetric distribution of design. It was notable that 42% of the buildings which failed were on street corners. In the majority of the cases these buildings had masonry walls on both sides of the corner joinings, and wide open facades on the other two sides. The torsion which provoked the failure significantly increased forces which occurred in the axes of the columns in front. In many other cases of buildings not located on the corners, there was failure due to asymmetric distribution of walls.
- b2) There is also the case in which there is much greater rigidity and resistance to lateral loads in the upper floors than in the first floor. This situation was seen in a large number of buildings in which there is an abundance of partition walls in the upper floors, while they do not occur in the lower floors such as in the

Distribución asimétrica de muros de mampostería en edificios en esquina  
Asymmetric distribution of masonry walls in corner buildings

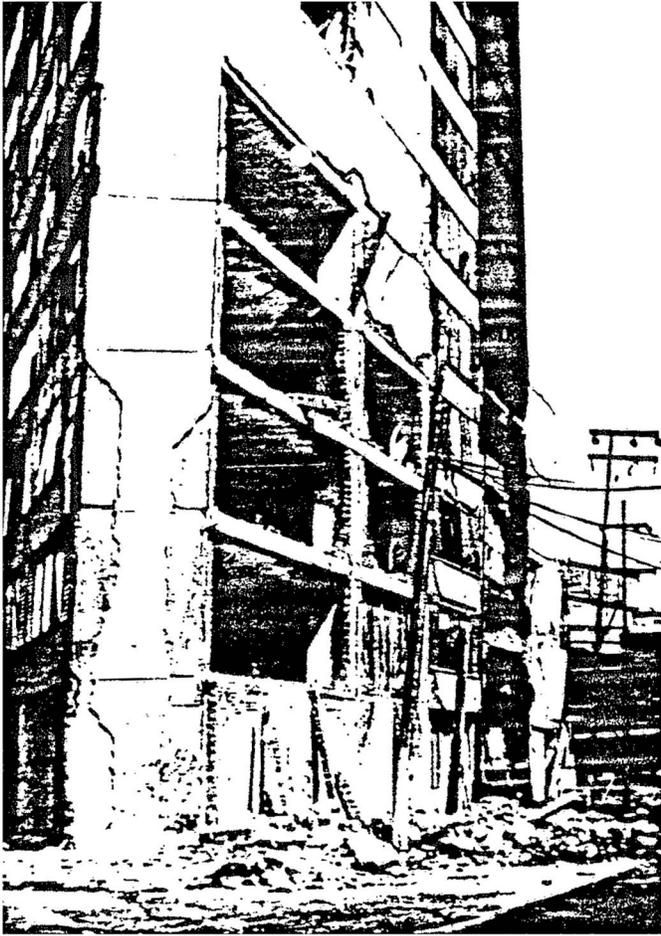
b3) Asymmetries caused by the destruction of walls. In diverse cases it was observed that walls made of weak material or badly anchored to the structure were totally destroyed by failures of normal bending or by shear; this resulted in loss of resistance to lateral loads of walls which were vital to maintain symmetry, thus increasing significantly the forces on the columns. The destruction of partition walls or of the adjacent ones was significant, in general, by the large lateral deformations to which the buildings were subjected.

Dstrucción de muros de relleno  
de mampostería

Destruction of walls filled with  
masonry.

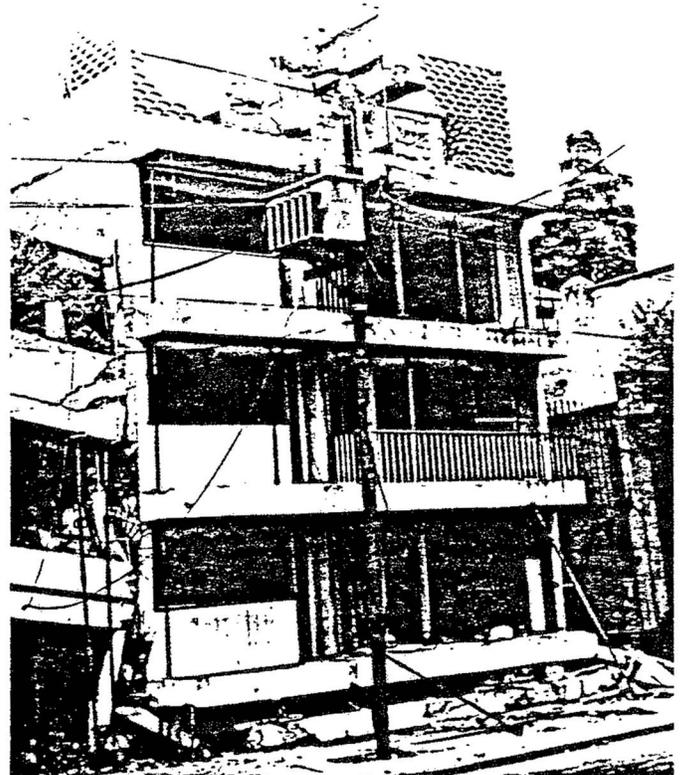
case of apartment buildings or lobbies of hotels. This causes a great demand in dissipation of energy concentrated in the first floor and propagates the failure of columns. This type of failures was very frequent and in many cases associated with the above.

Colapso de planta baja débil

Collapse of weak ground floor
